RICAMBI / SPARE PARTS

movida

ISTRUZIONI DI INSTALLAZIONE / INSTALLATION INSTRUCTION

ART. 5612/P/E
ART. 5612/2/P/E
ART. 5612/3/P/E
ART. 5612/4/P/E

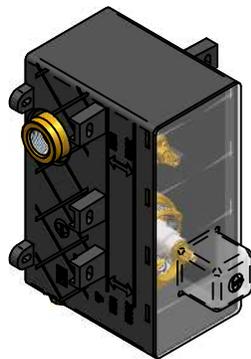
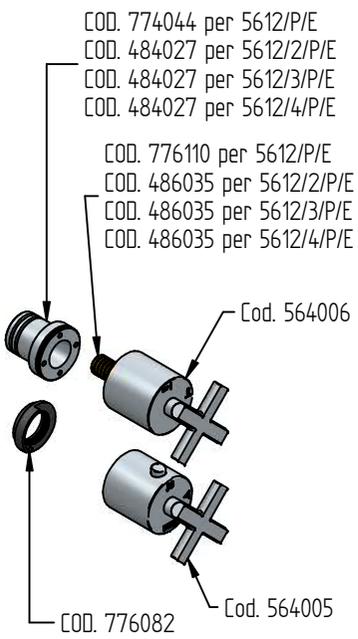
COD. 774044 per 5612/P/E
 COD. 484027 per 5612/2/P/E
 COD. 484027 per 5612/3/P/E
 COD. 484027 per 5612/4/P/E

COD. 776110 per 5612/P/E
 COD. 486035 per 5612/2/P/E
 COD. 486035 per 5612/3/P/E
 COD. 486035 per 5612/4/P/E

Cod. 564006

COD. 776082

Cod. 564005

Cod. 884034 per 5612/P/E
 Cod. 484028 per 5612/2/P/E
 Cod. 484029 per 5612/3/P/E
 Cod. 484030 per 5612/4/P/E

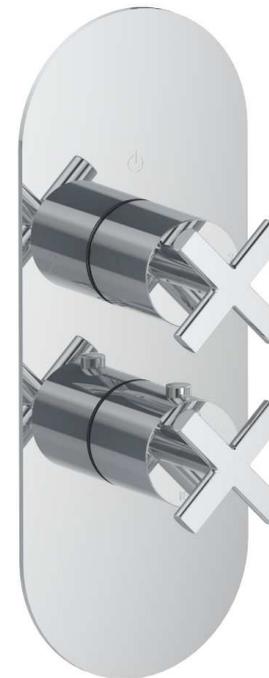
PER INSTALLAZIONE INCASSO VEDI ISTRUZIONI 484020, 484021, 484022, 484023
FOR BUILT-IN PARTS, SEE INSTRUCTIONS OF 484020, 484021, 484022, 484023

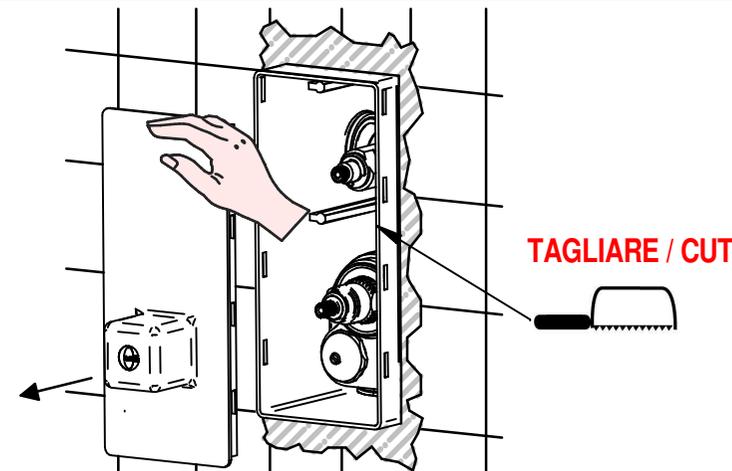
1

TAGLIARE / CUT

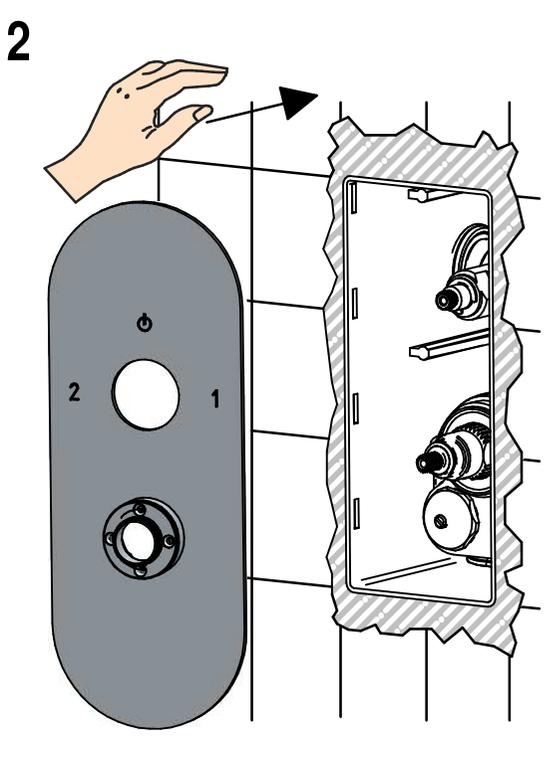
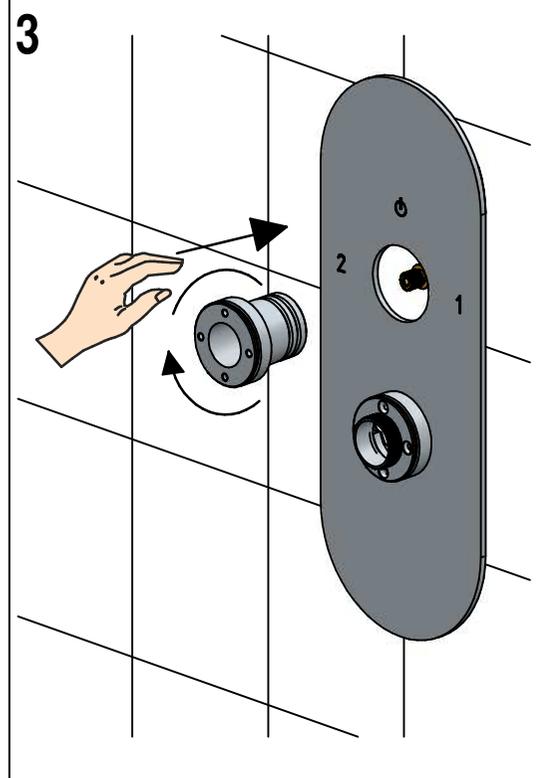
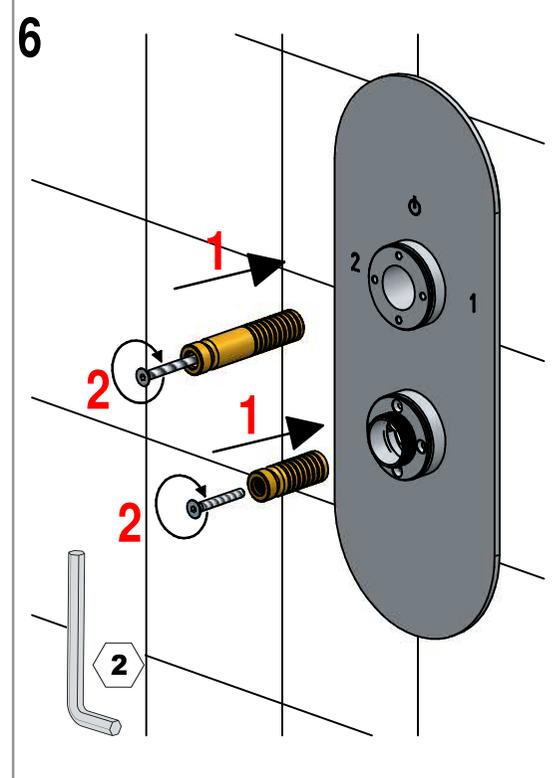
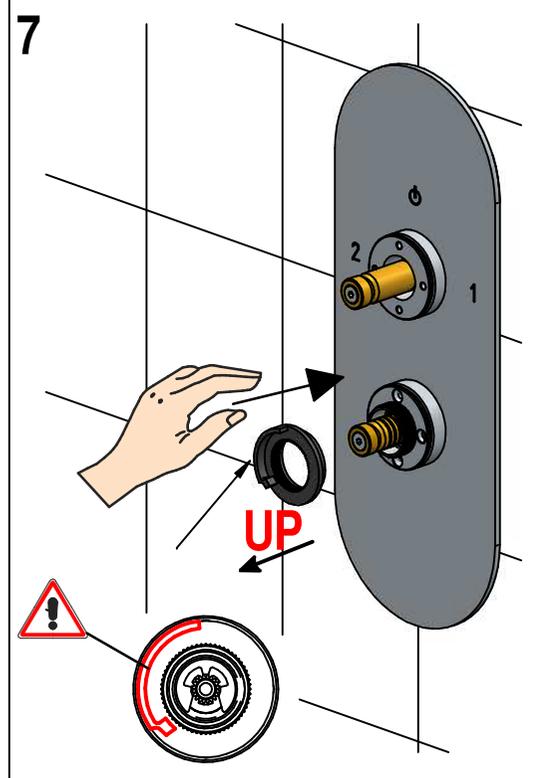
4

N= INTAGLI DA TAGLIARE ALLE ASTE BROCCIAE E VITI

N=NUMBERS OF NOTCH TO BE CUT FROM BROACHING ROD AND SCREWS

$N = (X - 27) / 3$

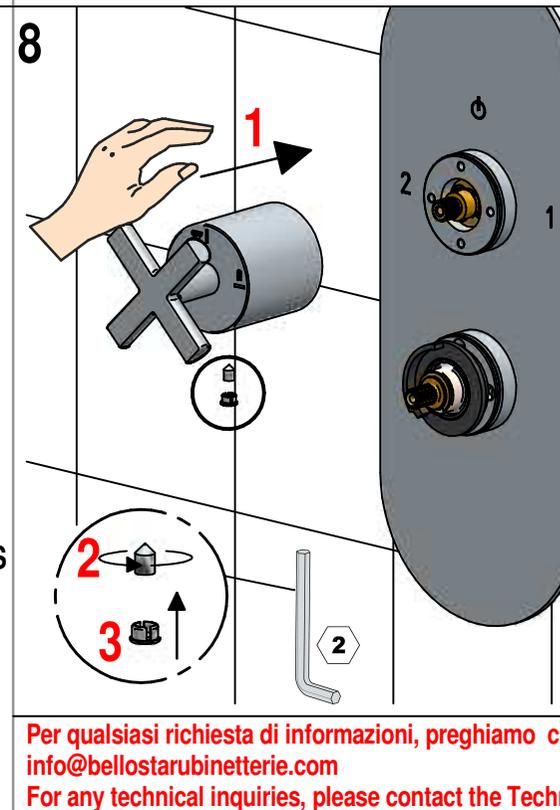
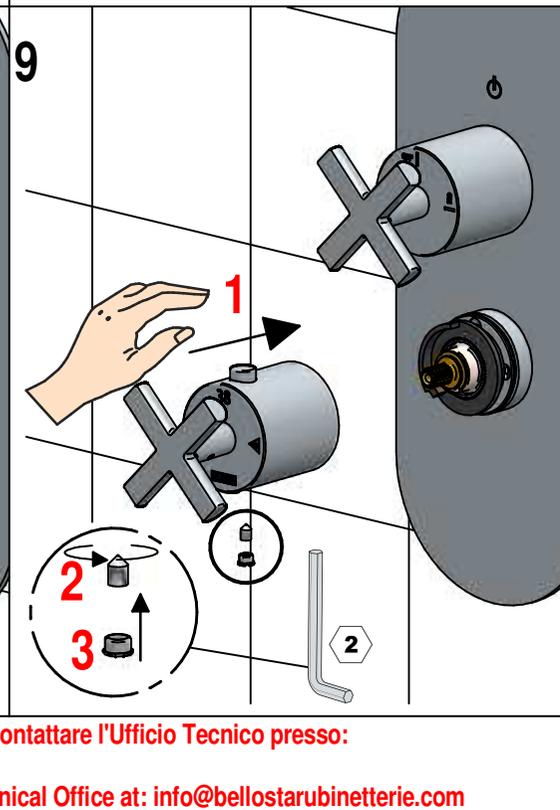
5

**! TAGLIARE ASTE BROCCIAE E VITI
CUT BROACHING RODS AND SCREWS**
